**DEPARTMENT OF TRANSPORTATION****DIVISION OF ENGINEERING SERVICES**

Quality Assurance and Source Inspection

Contract #: 04-0120F4Cty: SF/ALA Rte: 80 PM: 13.2/13.9File #: 69.28**WELDING INSPECTION REPORT****Resident Engineer:** Pursell, Gary**Address:** 333 Burma Road**City:** Oakland, CA 94607**Report No:** WIR-000101**Date Inspected:** 15-Mar-2007**Project Name:** SAS Superstructure**OSM Arrival Time:** 800**Prime Contractor:** American Bridge/Fluor Enterprises, a JV**OSM Departure Time:** 1730**Contractor:** Zhenhua Port Machinery Company, Ltd (ZPMC), Changxing Island **Location:** Shanghai, China**CWI Name:** Liu Liu**CWI Present:** Yes No**Inspected CWI report:** Yes No N/A**Rod Oven in Use:** Yes No N/A**Electrode to specification:** Yes No N/A**Weld Procedures Followed:** Yes No N/A**Qualified Welders:** Yes No N/A**Verified Joint Fit-up:** Yes No N/A**Approved Drawings:** Yes No N/A**Approved WPS:** Yes No N/A**Delayed / Cancelled:** Yes No N/A**Bridge No:** 34-0006**Component:****Summary of Items Observed:**

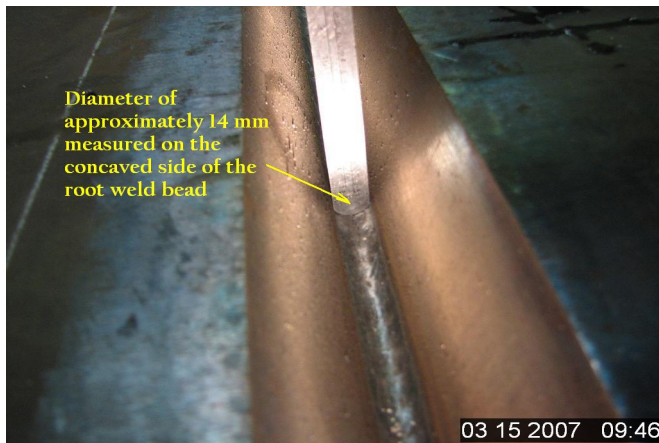
The QA inspectors had a conversation with ZPMC representatives. The QA inspector recommended performing magnetic particle testing (MT) to the root passes for PQR HP 200712-1 and HP 200712-2 (rejected previously by ZPMC). ZPMC performed MT verifications to the PQR test coupons. ZPMC observed that the first and second test specimens had root cracks on the weld metal. The QA inspector concurred with ZPMC observations.

The QA inspector had a conversation with the Caltrans Task Leader Dave McClary. The QA inspector Mike Hasler and the QA inspector brought to the attention of Mr. McClary that the welds that failed on the PQR HP200712-1 and HP200712-2 were concave shapes which have a tendency to cause centerline cracking when are using in procedures or with electrodes that develop too concave bead shape (solidification at the centerline of the weld combined with surface tensions due to shrinkage could be a cause centerline cracking).

The digital photograph below shows the concave root bead for the PQR HP200712-2.
